HMS COLOSSUS

SURVEY REPORT 2002

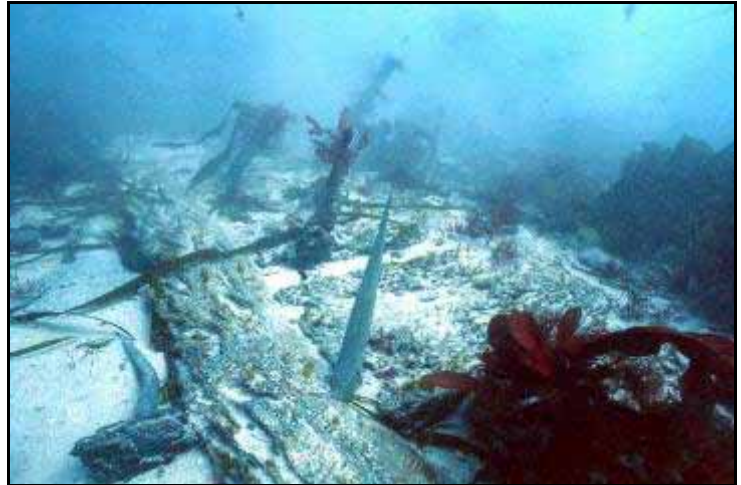
S2 Copper alloy fastenings and timber on the north side of the wreck. The hull outer planking is on the left and the frames are in the centre of the picture.

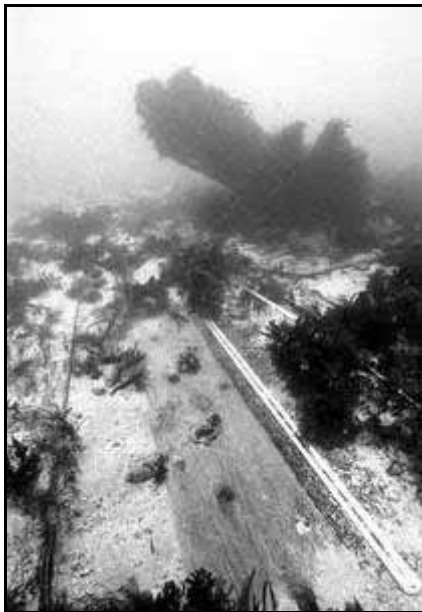
S3 Inner planking and frames – gun 5 in the background – looking west.

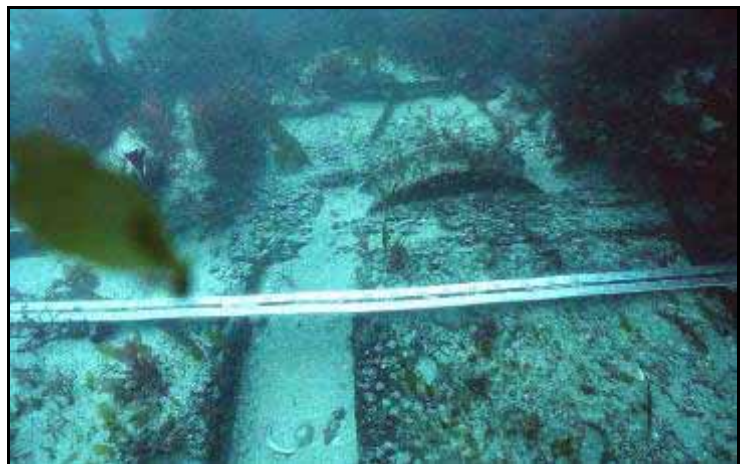
S5 Sheave (pulley wheel) incorporated into the hull to the west of gun 2.

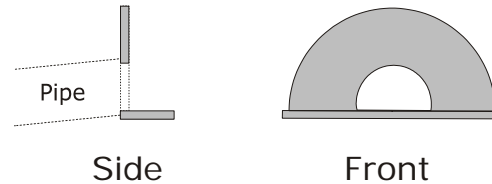
Three lead scupper pipes were observed, all situated just above the deck surface on the upper gun deck (see plan for locations). Two of these are partially eroded, but the centre pipe clearly shows the arrangement of the flange on the inner end of the pipe – see sketch opposite. These flanges must have been

Sketch of the lead scupper pipe flange found on the upper gun deck.

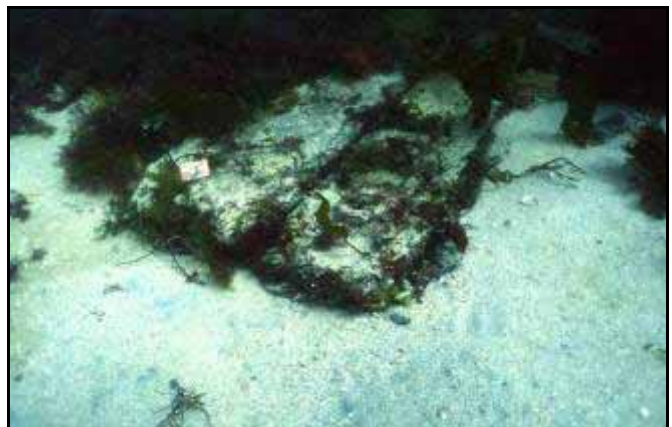
The survival of the timbers of the wreck is remarkable. It is clear from the survey that some parts of the wreck have fared better than others. On the south side of the wreck (south of the line of guns) mostly only the outer planking of the hull survives, probably because this is one of the highest points of the wreck so the timbers have been exposed for longer. Similarly, around the guns themselves the inner planking is mostly missing, the frames being mostly what is visible. Just to the north of this, where the wreckage is slightly lower, all the timber of the hull is intact – hence the inner planking is what is visible. A line of hanging knees are visible to the north of the upper gun deck planking. Near the stern the hull only survives up to the level of the upper gun deck. All the timber which is currently exposed will disappear in the next few years unless there is an increase in the sand levels and they are reburied.

S9 (below) Scouring around the timbers of the wreck – by control point I (centre left), looking north-east.

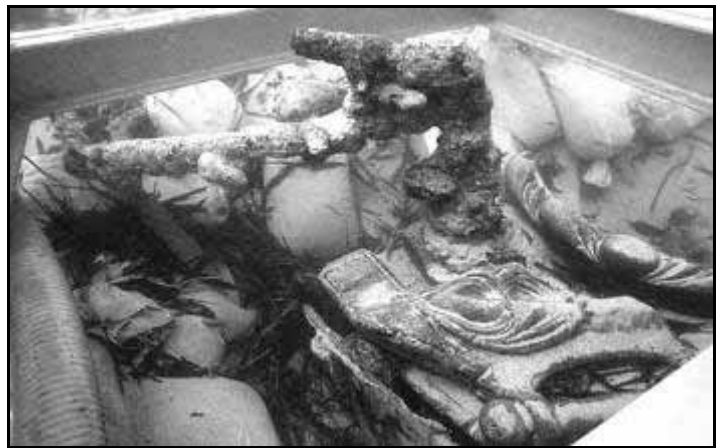
C3 Iron bracket above the window arch on the carving – possible stern lantern bracket.

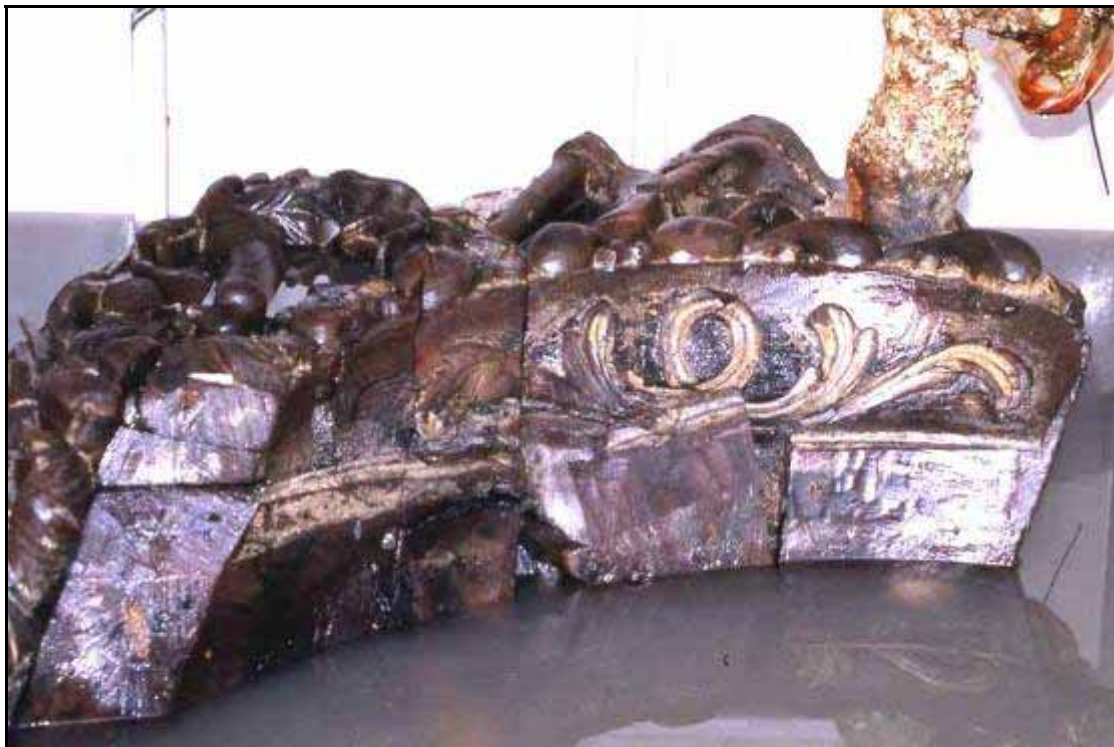
C11 The carving [285] – detail showing the underside of the window arch. Note the traces of dark paint and the remains of gilding to the relief scrollwork.

On close examination it was clear that Oscar had come through his ordeal relatively unscathed – a testimony to the efficacy of the lifting system employed. There was some minor damage to the underside of the window arch. The damage consisted of the partial displacement of a largely undecorated board on the underside of the arch and some slight flexing of the arch itself – see photograph. In my opinion the damage could well have occurred even if the lift had gone as planned. I have since had an opportunity to study the carving in detail on land (while making record photographs with Charlie Barker of Mary Rose Archaeological Services) and I feel confident that the damage is minor and easily repairable. This was a difficult and complex lifting operation, undertaken entirely at Mr Mace's expense.

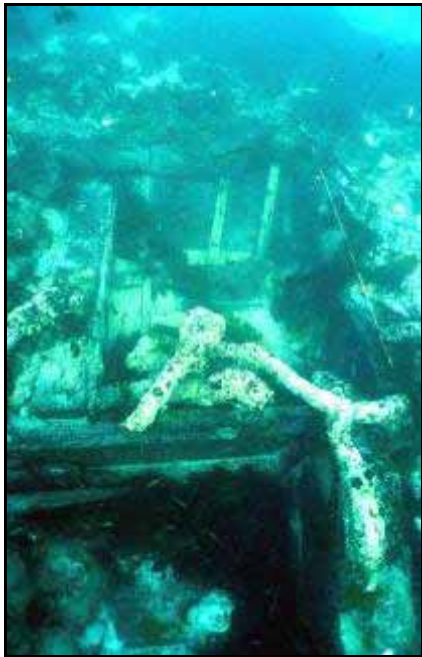
E3 Exploratory trench – orlop in the background, main gun deck foreground. Note the ironwork over the upstanding deck planks.

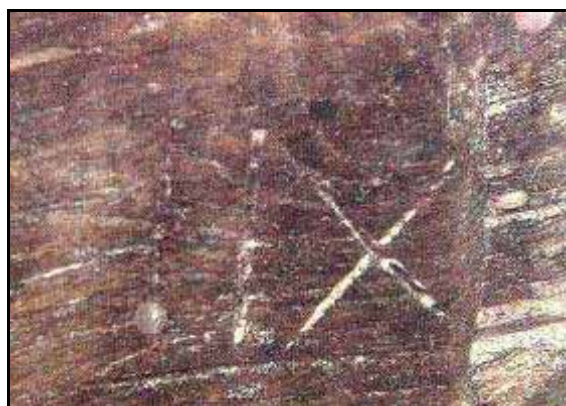
E8 Detail of the eastern knee on the orlop deck, showing possible builders' mark 'IIX'. Photograph by Robin Witheridge.
