HMS Colossus Dive Trail

Read this page before the dive

HMS Colossus was a 74 gun warship built in 1787 at Gravesend and wrecked in 1798. These 74 gun ships were one of the most successful types of the period. They were about 51m (170 feet) in length and had a crew of over 600. During her relatively short working life (eleven years) *Colossus* saw action at Toulon, Groix, Cape St Vincent and Cadiz. She also took part in the capture of two enemy ships *Le Vanneau* and *Vrai Patriot* in 1793

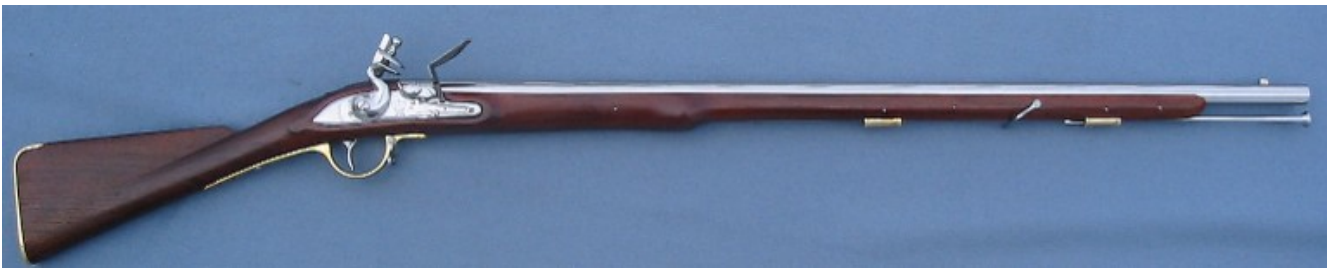
2

This is what the now corroded muskets would have looked like. The musket was fired using black powder (gun powder), which was ignited by sparks generated by a flint striking a steel plate.

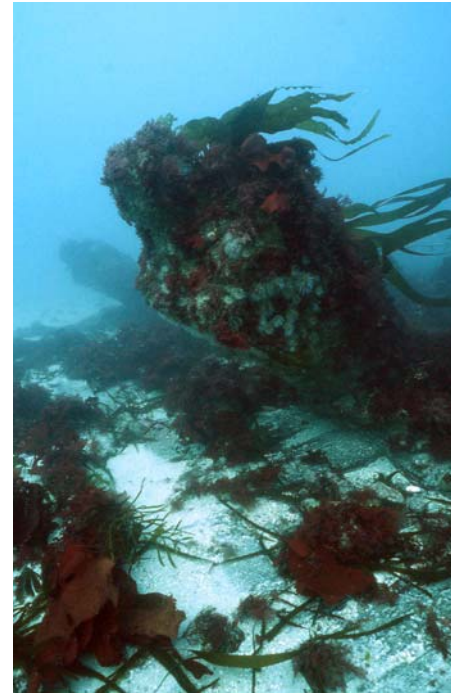
3

Colossus carried 74 guns on three different levels. These were all smooth-bore cast iron guns designed to fire a variety of projectiles (grape, case, bar, chain and round shot). The guns were classified according to the weight of round shot they fired. The lower gun deck had 28 thirty-two pound guns; the upper deck had 28 eighteen-pound guns while the quarterdeck and forecastle held the remaining 18 nine-pound guns. The guns visible on site are eighteen-pound guns of the Armstrong type, while the lower deck guns were the newer Blomefield design.

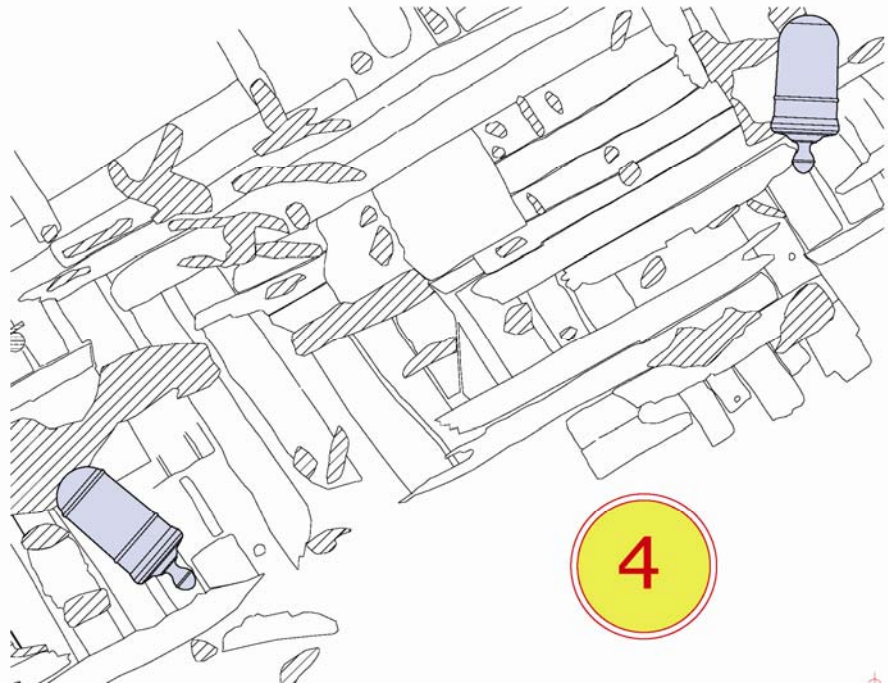
About two metres to the north of station 4 you will find an empty gun port. This gives a clear idea of what the gun ports looked like. Remember you are looking at the inside of the gun port. Notice the corroded iron ring bolts at the side of the gun port, which would have been used to secure the gun carriage to the side of the ship. If you look closely at the timber on the seabed, you will see the tunnels in the timber created by the wood-boring organisms which are attacking the hull timbers.

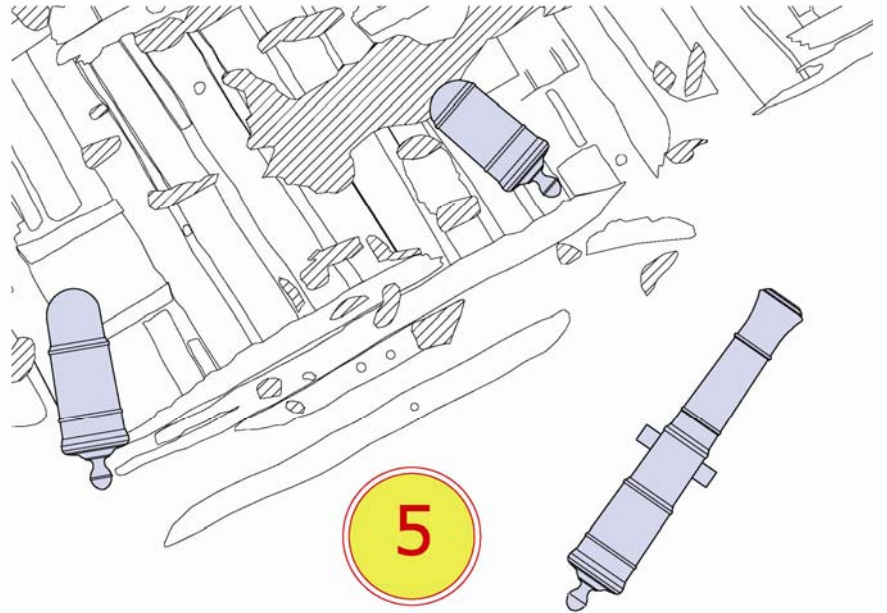
At station 5 you can see one of the eighteen-pound guns lying flat on the seabed. This gun is probably the one which was originally sited at the empty gun port you saw at station 4. Here you can see just how large these guns are. They are 2.75m (9 ft) long and weigh 2 tonnes each. The lower deck guns (thirtytwo-pound) were even larger.

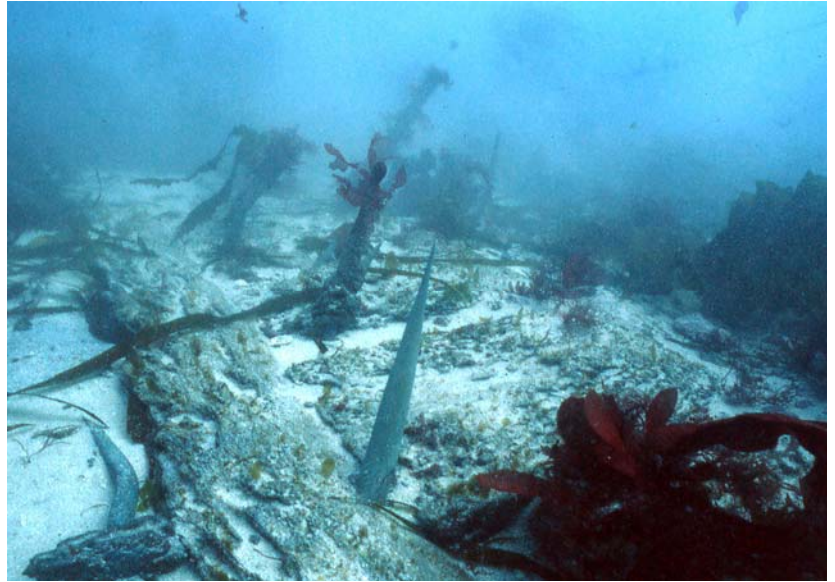
7

The timbers you see here are the partly buried hull timbers. These consist of the inner planking, frames and outer planking. You are at the level of the orlop deck, where cables and sails were stored, below the water line of the vessel.

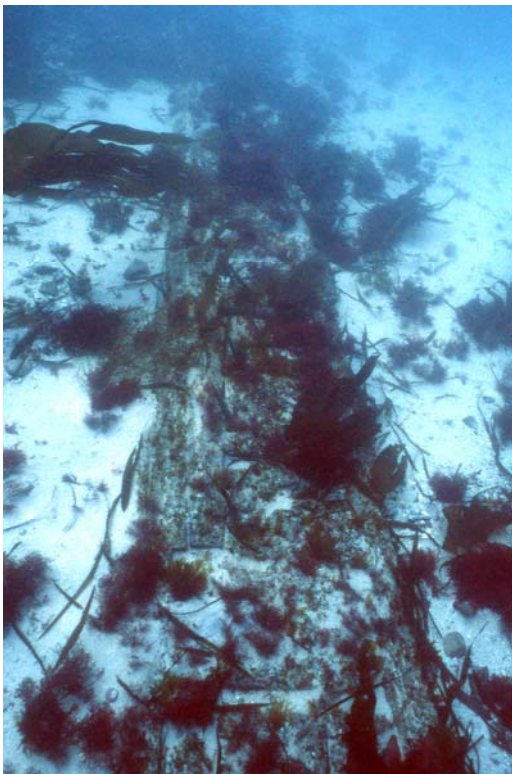
The photograph here shows you roughly what the hull timbers look like at this point (looking east). On the left is the outer hull planking. In the middle, the large square timbers are the frames of the ship. On the right hand side is the inner planking. If you look carefully you should be able to see the joins in the planking. Again you will notice how the timbers are being attacked by wood boring organisms – sometimes called gribble.

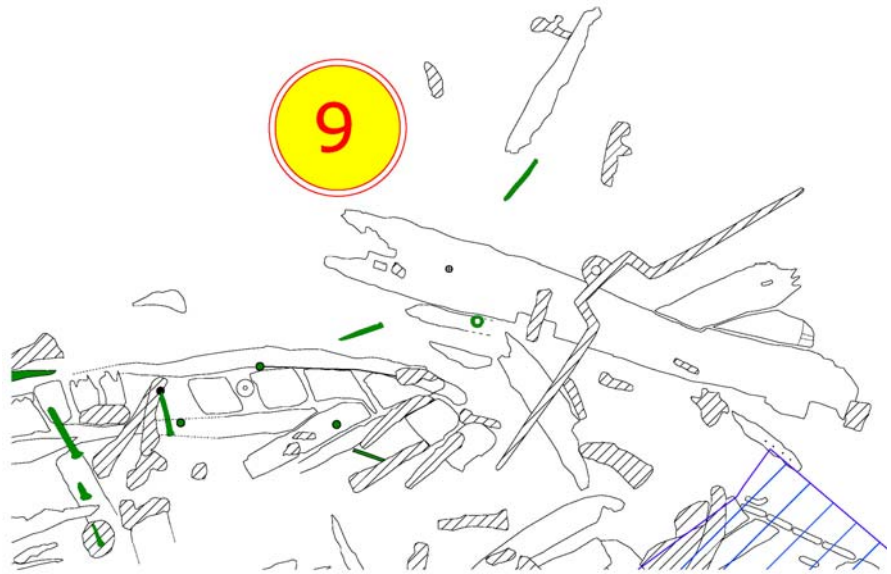
9

Here you can see part of the stern post of the ship. The large iron object on top of the timber is one of the rudder gudgeons, an iron strap used to attach the rudder to the hull (the gudgeons attach to the hull and the pintols attach to the rudder). The hole in the centre of the gudgeon is where the rudder pivoted on the pintol pin. Colossus lost her rudder when she first grounded some distance to the west of where you are now.

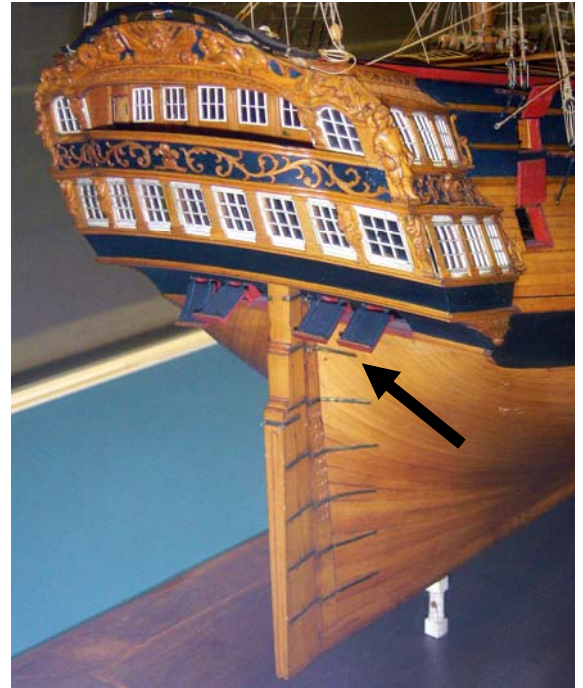
9

This photograph of the stern of a model of a similar ship shows the position of the rudder gudgeon (arrowed).
