Her Majesty's Fire-Ship

Firebrand

Shipwreck Recording Project

Project Design 2009

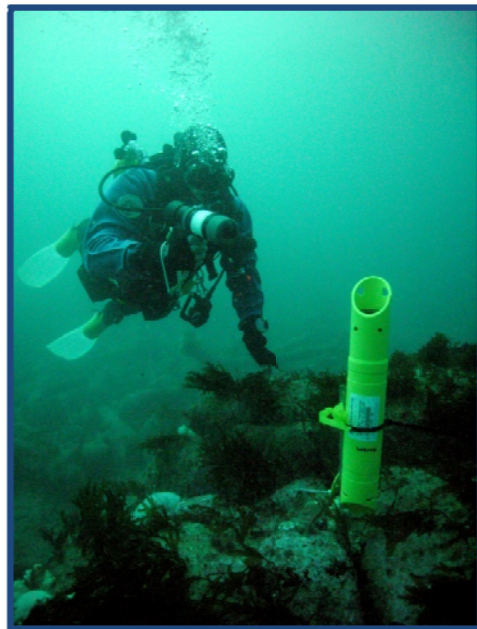
Cover photograph – Survey in progress using a Sonardyne Homer-Pro electronic tape measure.

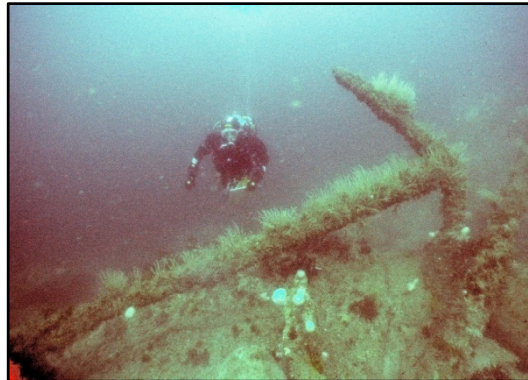
Fig 3 One of the Firebrand's four bower anchors – note the missing upper fluke.

Most of the wreckage appears to be *in situ*. A striking exception is the gun and bower anchor standing propped against each other at the northern end of the site (Fig 2). This gun and anchor are not shown in this position on the 1981 Morris sketch – they may have been moved there and used as a mooring by the Morris team.

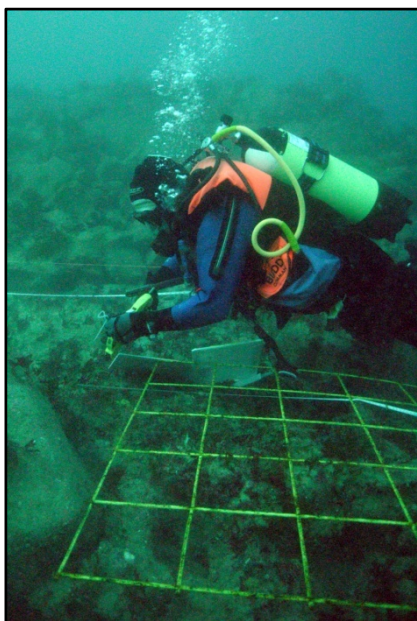
Fig 8 Survey in progress 2008
